BULLETIN

1.UA.2007

Company Urban Air prescribe make valid immediatelly change of flaperon pushrod laminated covers on left and right wing (see photo No. 1) on the airplanes UFM 13 Lambada.

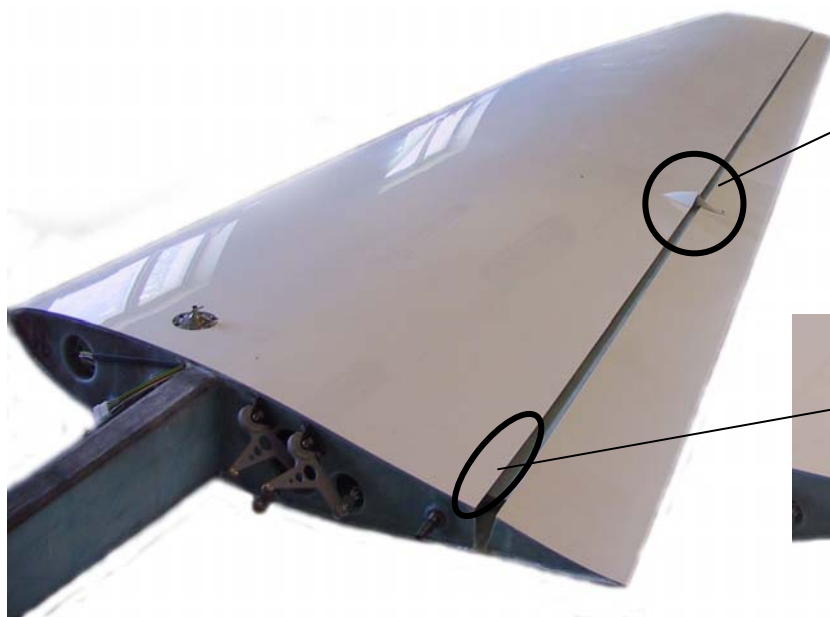
Obr. 1.

We found, that on maximum load of the wing (flight envelope limits) deflection of the wing can make situation, when pushrod connection screw touch the laminated cover. Also bottom surface on the left and right wing can touch the flaperon. Because of this two reasons forcer on the control stic can increase.

It is necessary to make change of small laminated covers of flaperons for new – bigger ones and grind away part of bottom surface on the left and right wing. Then movement of control lines is free on all points of flight envelope.
